THE UNITED STATES  
STRATEGIC BOMBING SURVEY

EFFECTS OF  
THE ATOMIC BOMB  
ON  
NAGASAKI, JAPAN

Physical Damage Division

June 1947

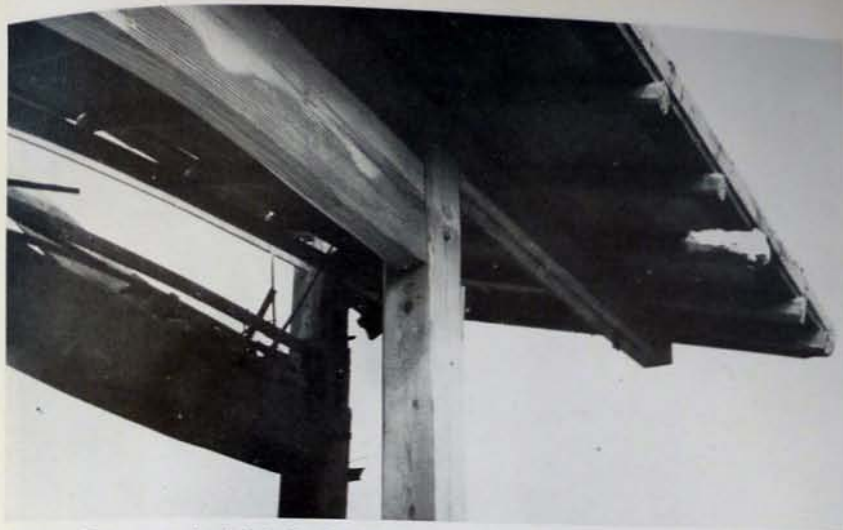
PHOTO 3.—Burns on unpainted timber lintel of Japanese house approximately 6,180 feet north of GZ. Light area above burned wood shaded by eaves from heat of atomic bomb.

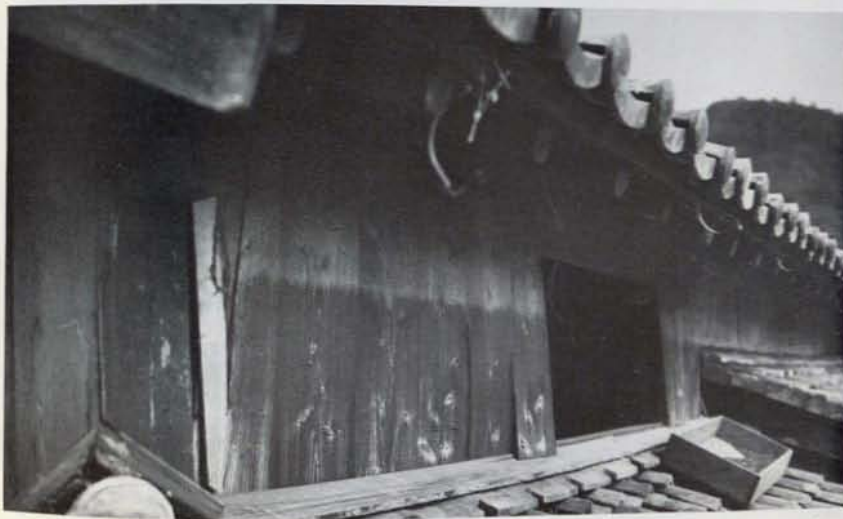
PHOTO 4.—Burns on unpainted wooden siding of Japanese house approximately 7,880 feet north of GZ. Light area above burned wood was shaded by overhanging eaves from heat of atomic bomb.

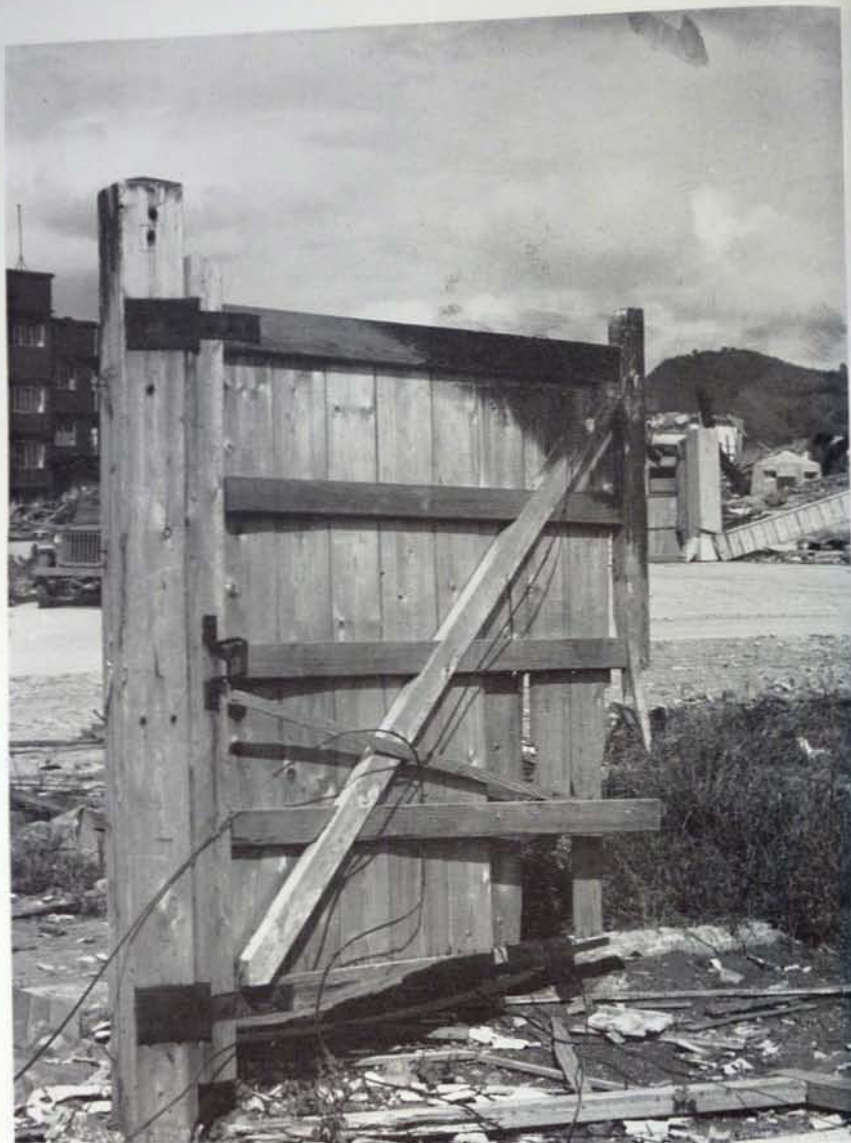
Photo 5.—4,650 feet from GZ. Flash burn on gate. AZ above and to the left.

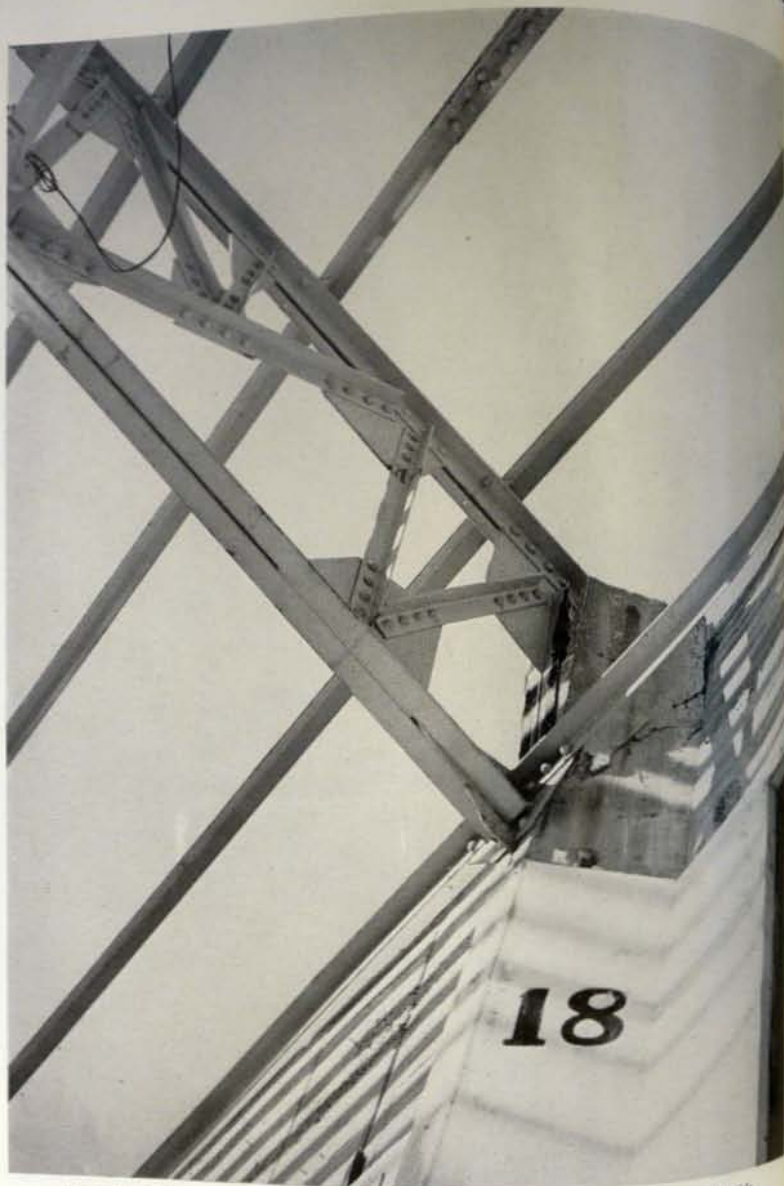
Photo 9.—5,500 feet from GZ. Group 4. Building 1. Typical column failure, north wall inside.

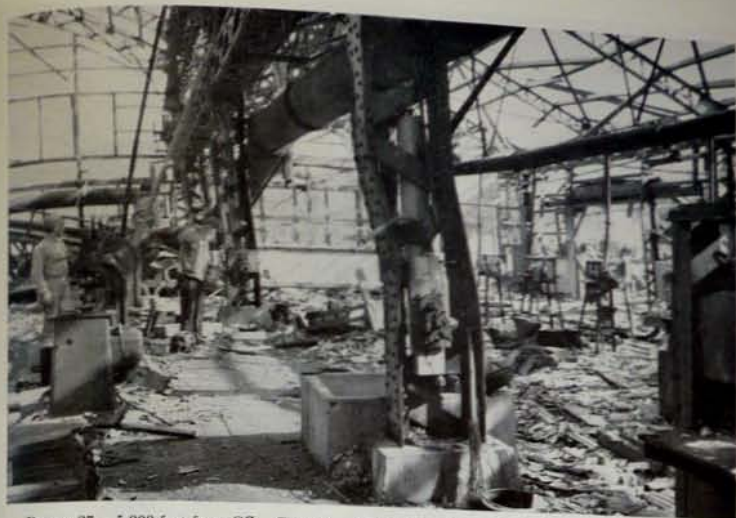
PHOTO 27.—5,000 feet from GZ. Group 4. Building 5. Column 4-C showing cracked foundation.

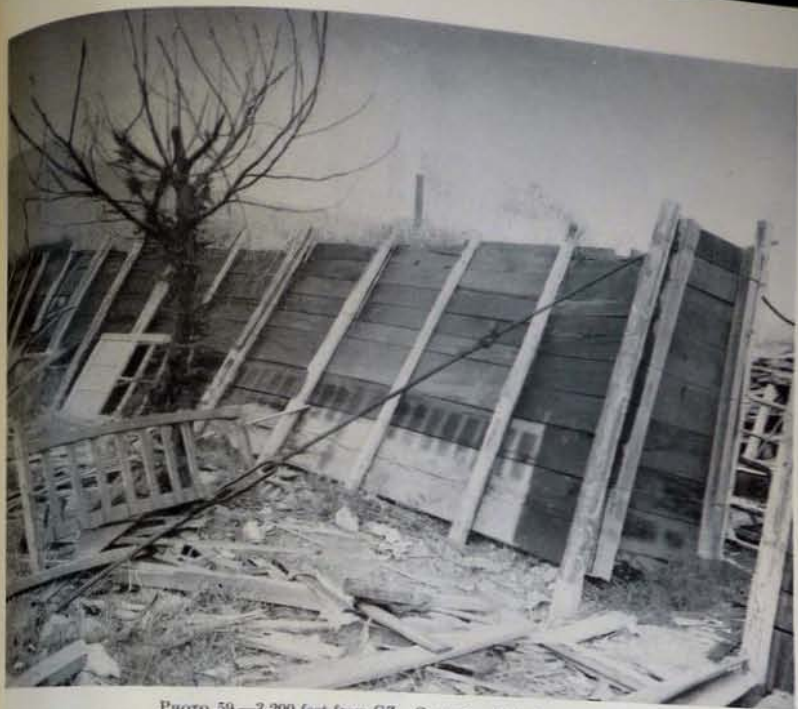
PHOTO 59.—3,200 feet from GZ. Group 5. Flash burns on blast wall.

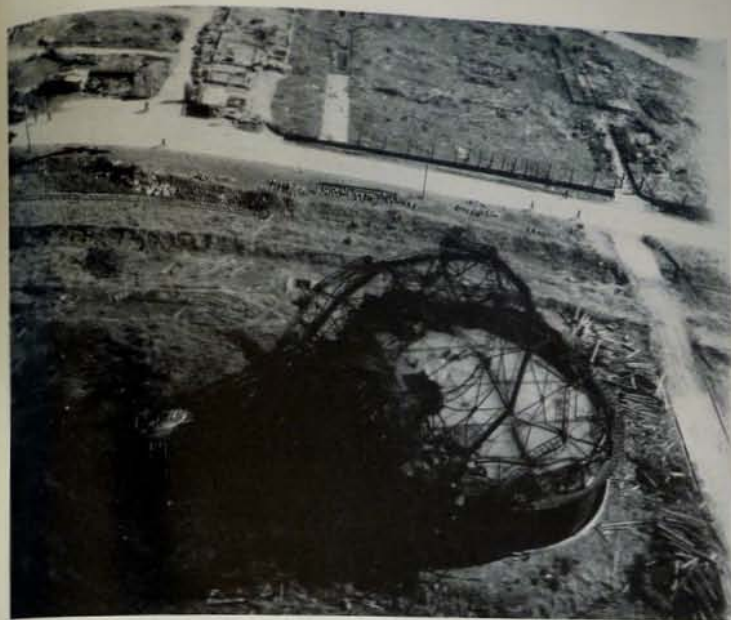
Photo 66.—3,200 feet from GZ. Ohashi Gas Works. View of gas holder damaged by blast of atomic bomb and low order detonation of contents.

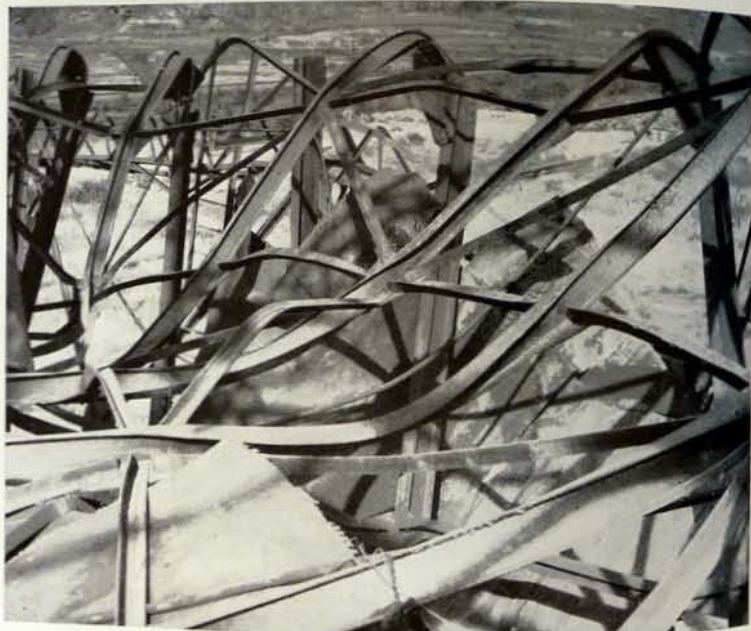
Photo 71.—3,200 feet from GZ. Group 6. Damaged tank top.

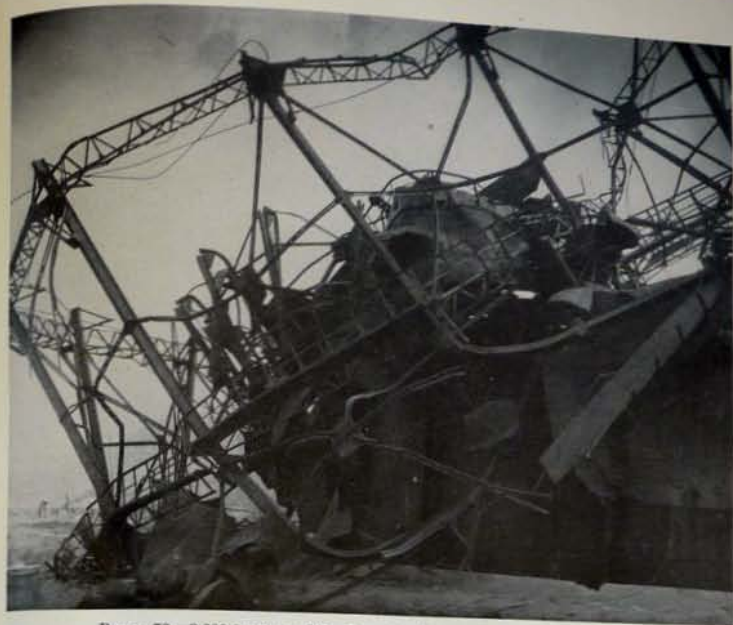
Photo 72.—3,200 feet from GZ. Group 6. Damaged gas holder, looking east.

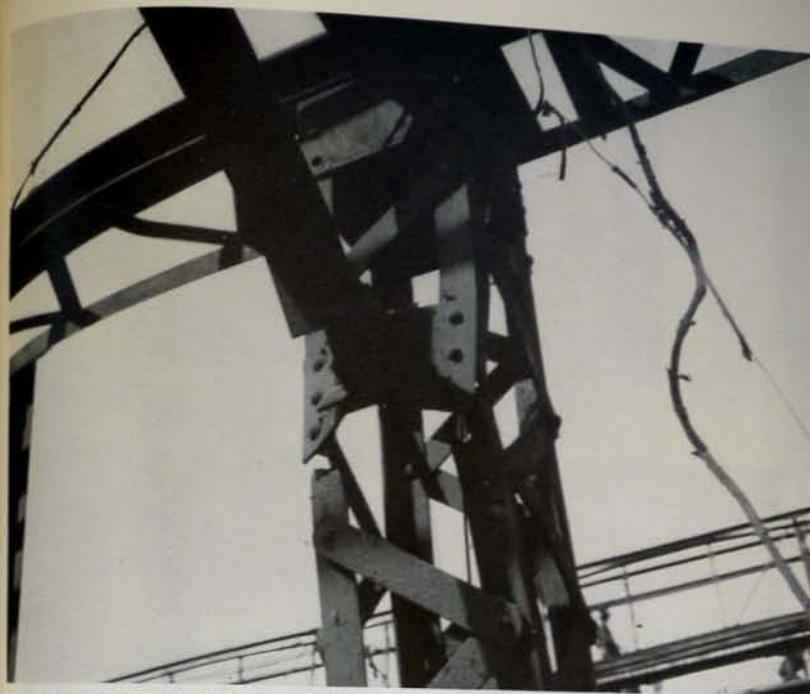
Photo 103.—2,800 feet from GZ. Group 26, Building 10A. Column 3A broken at knee brace. Typical of columns 1A, 2A, 3A, and 4A in this building.

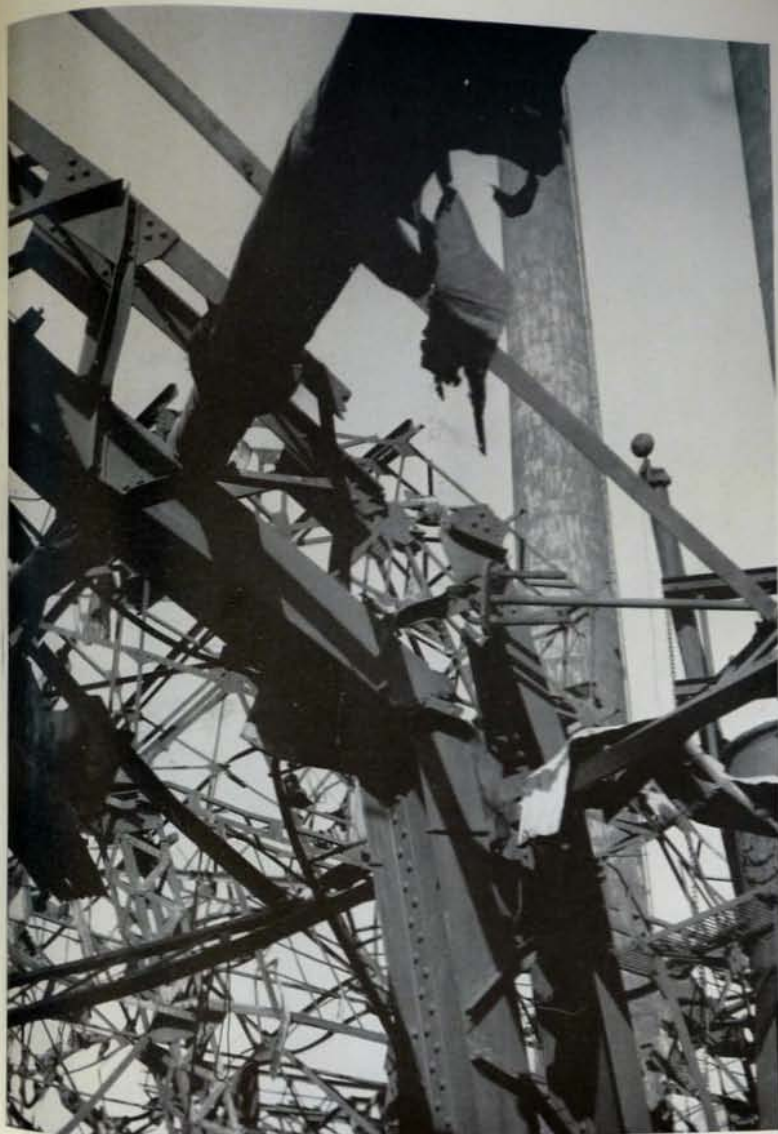
Photo 109.—3,200 feet from GZ. Group 26, Building 11A. Broken column in north wall of building.

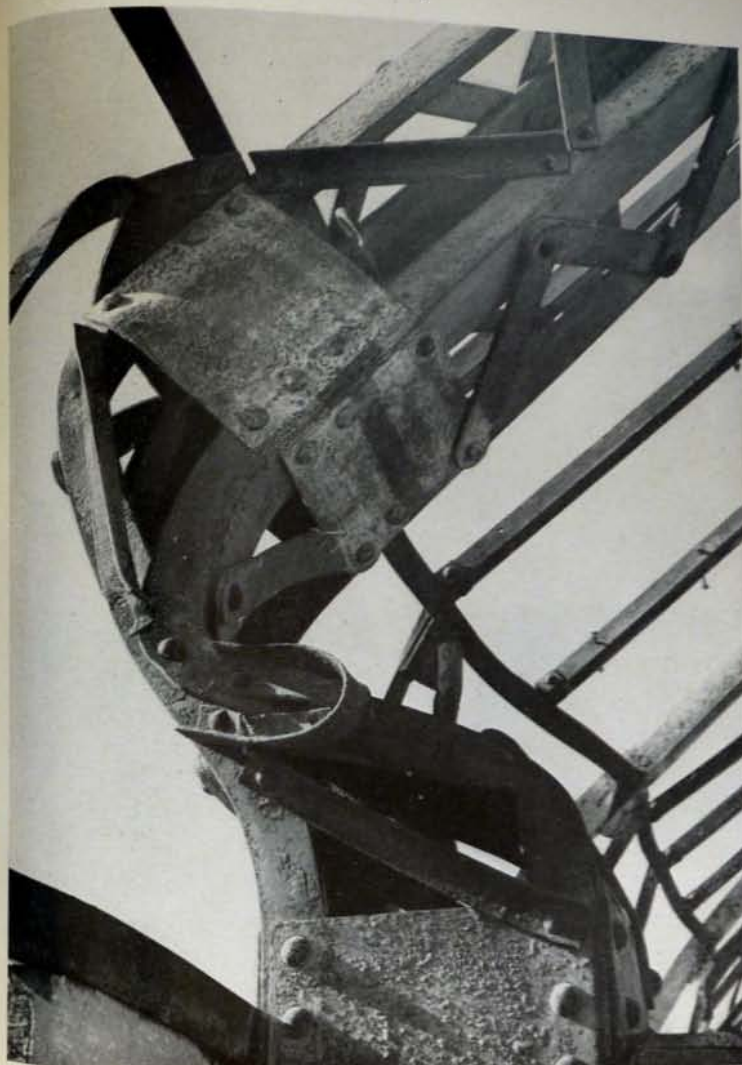
Photo 182.—Group 35, Building 1. Looking north at base of Column 3C. Steel at this point softened by fire in wooden plank flooring. Typical of damage to Columns 2C, 3C, 4C, 5C, and 6C.

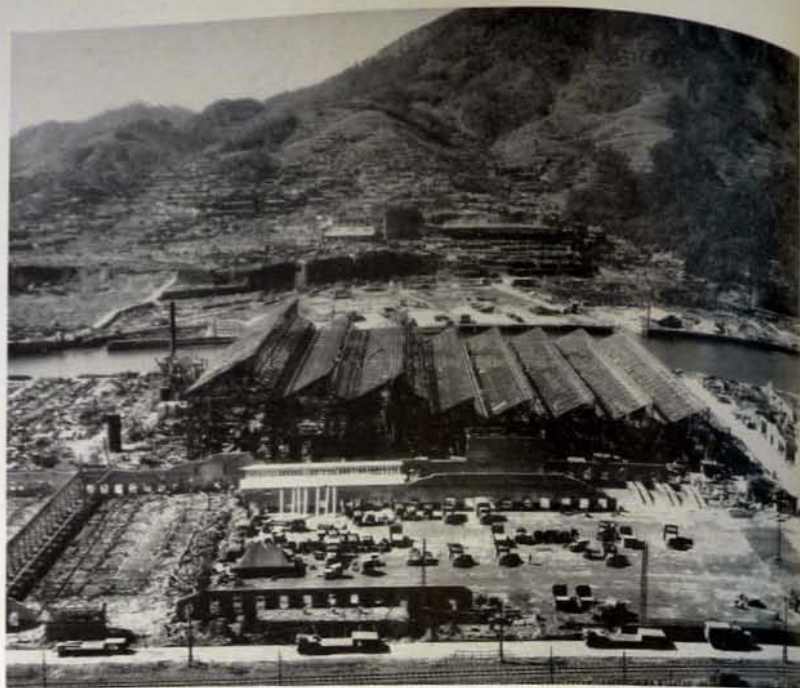
PHOTO 191.—5,600 feet from GZ. Group 36, Building 8. Aerial view, looking west.

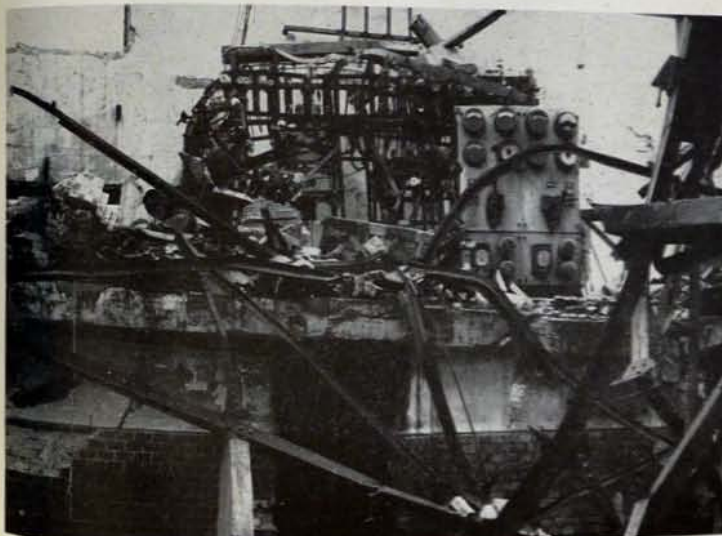
PHOTO 204.—6,700 feet from GZ. Group 39. East end of Turbine room. Damage to roof truss.

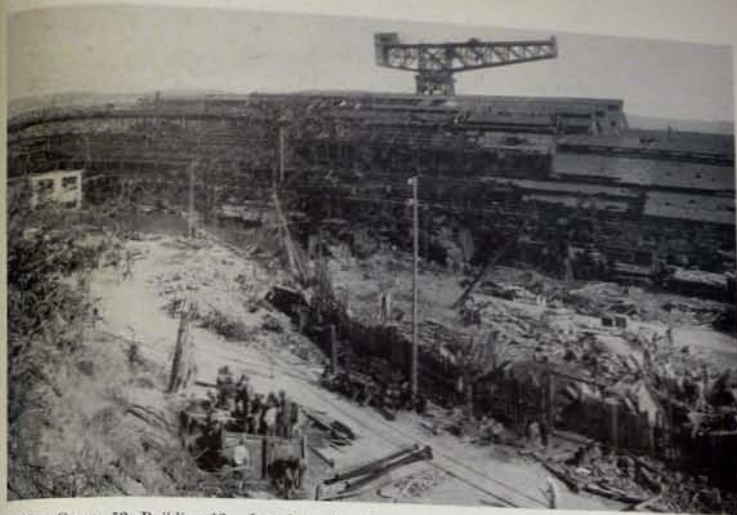
Photo 245.—Group 52, Building 12. Jap photo dated 7 August 1945. Heavy structural and superficial damage to foundry by high-explosive bombs.

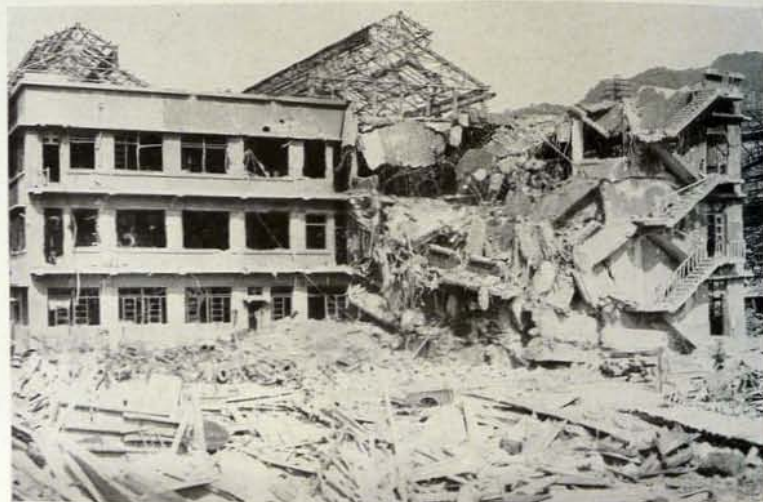
Photo 248.—Group 52, Building 14. Jap photo dated 7 August 1945. Building damaged by high-explosive bombs and gutted by fire.

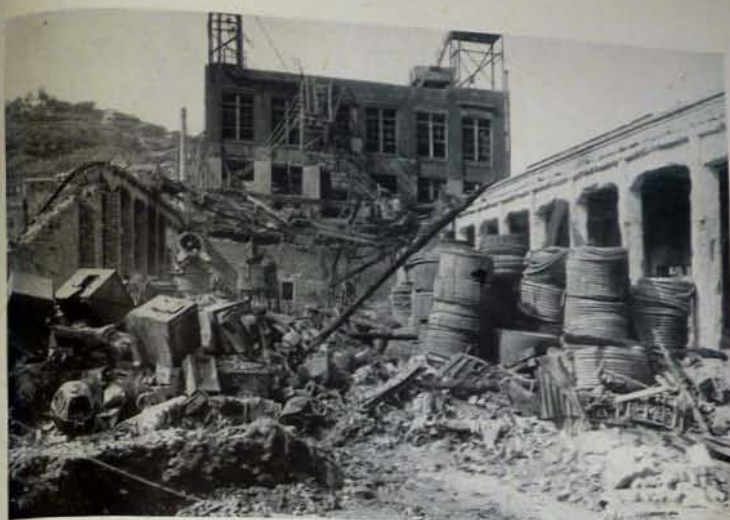
PHOTO 269.—Group 52, Building 17c. Jap photo dated 7 Aug. 1945. Storeroom completely burned out.

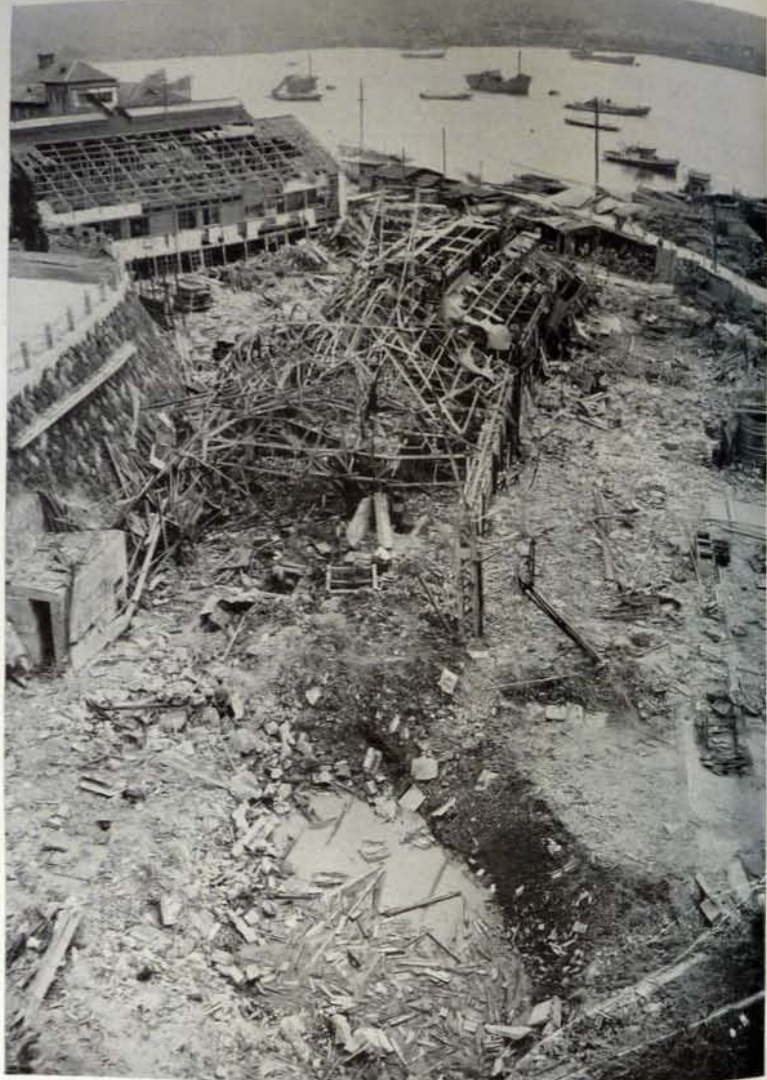
Photo 271.—Group 52, Buildings 19 A and B. Jap photo dated 7 Aug. 1945. Light steel buildings almost destroyed by HE bombs.

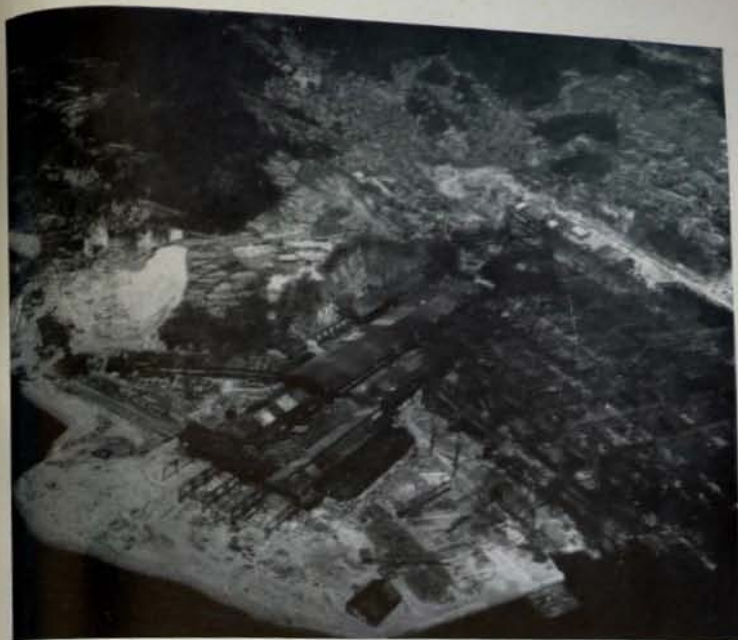
Photo 283.—Group 54, Building 12. Damage done by HE bomb prior to atomic-bomb attack.
